**CONNECTICUT RIVER BASIN
GLASTONBURY, CONNECTICUT**

**ADDISON POND DAM
CT 00245**

**PHASE I INSPECTION REPORT
NATIONAL DAM INSPECTION PROGRAM**

APRIL 1981

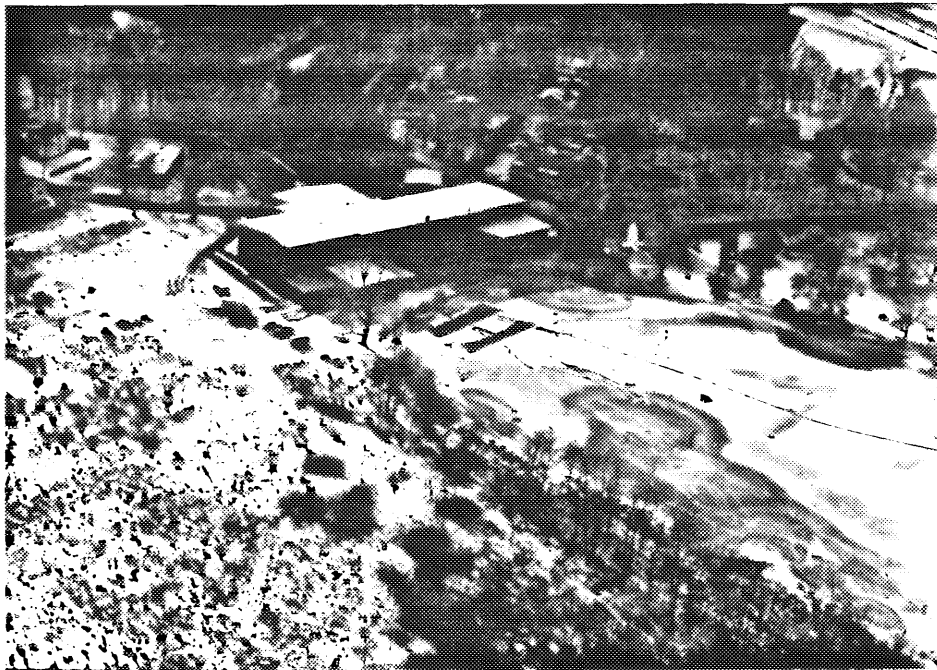
GOODKIND & O'DEA INC.- SINGHAL ASSOCIATES/LJO ENGINEERS		U.S. ARMY ENGINEER DIV. NEW ENGLAND CORPS OF ENGINEERS WALTHAM, MASS.	
NATIONAL PROGRAM OF INSPECTION OF NON-FED. DAMS			
OVERVIEW PHOTO OF DAM			
ADDISON POND DAM GLASTONBURY, CONNECTICUT			
DRAWN BY	CHECKED BY	APPROVED BY	SCALE: NONE
E.T.K.	W.J.W.	L.J.B.	DATE: APR., 1981 SHEET 1

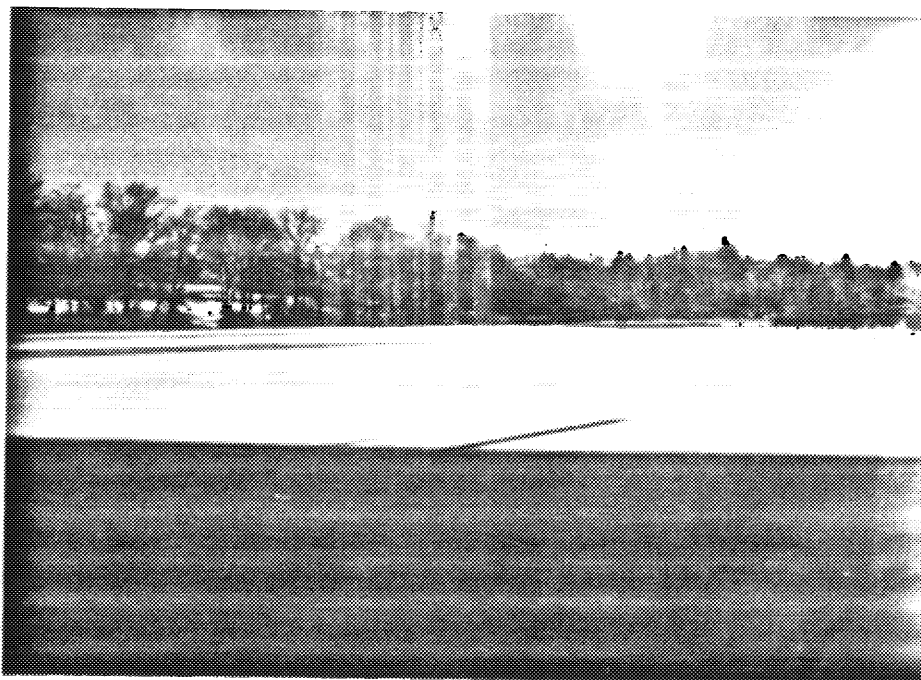
Addison Pond is a small body of water located in a mostly undeveloped area with numerous large trees along its shore (See Photo 7).

Photo 7 - View of pond from the dam.
